# WELL RECONDITIONING

## AWWA 2015 ANNUAL CONFERENCE

**HANSEN  
ALLEN  
& LUCE<sup>INC.</sup>**

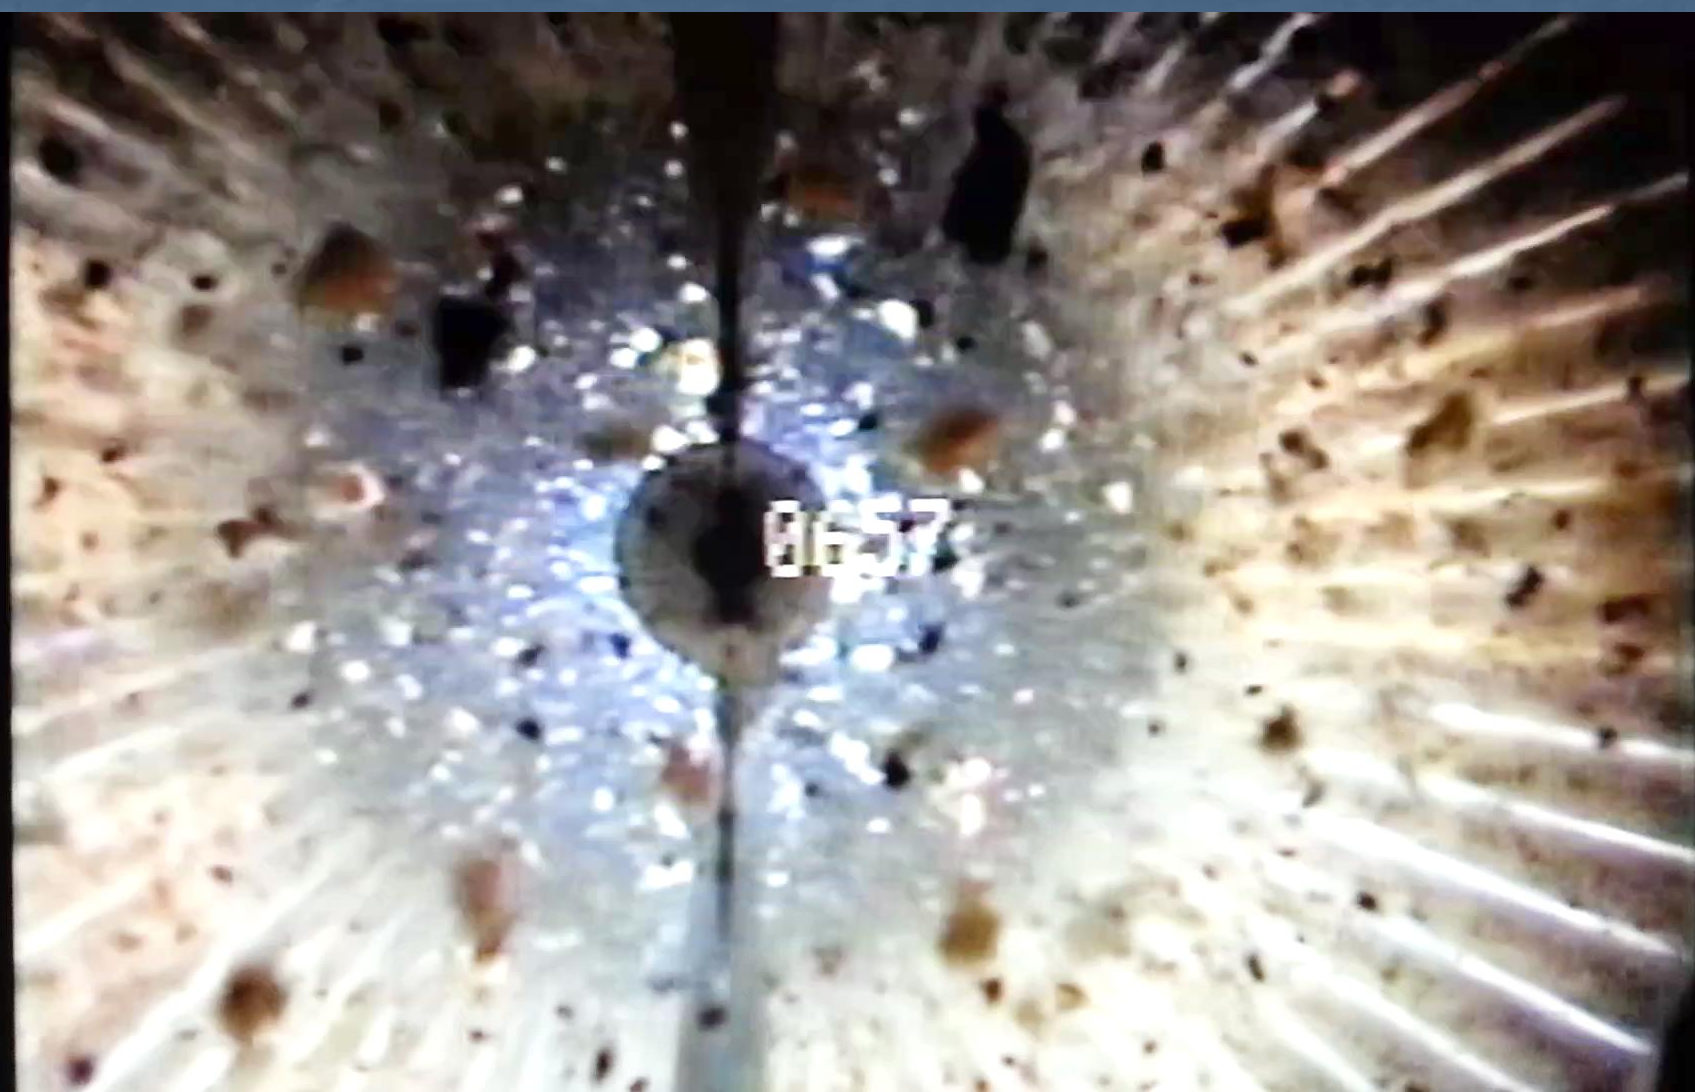
# Case History #1 - 16" Well 880 Feet Deep

1997: Yield 800 gpm

2001: Yield 400 gpm

Problem: Heavy Biofouling

Reconditioning: Chemical Treatments

Cost: \$100,000 (2012) to \$ 8,000 (2014)

Results: Restoration of 800 gpm Yield

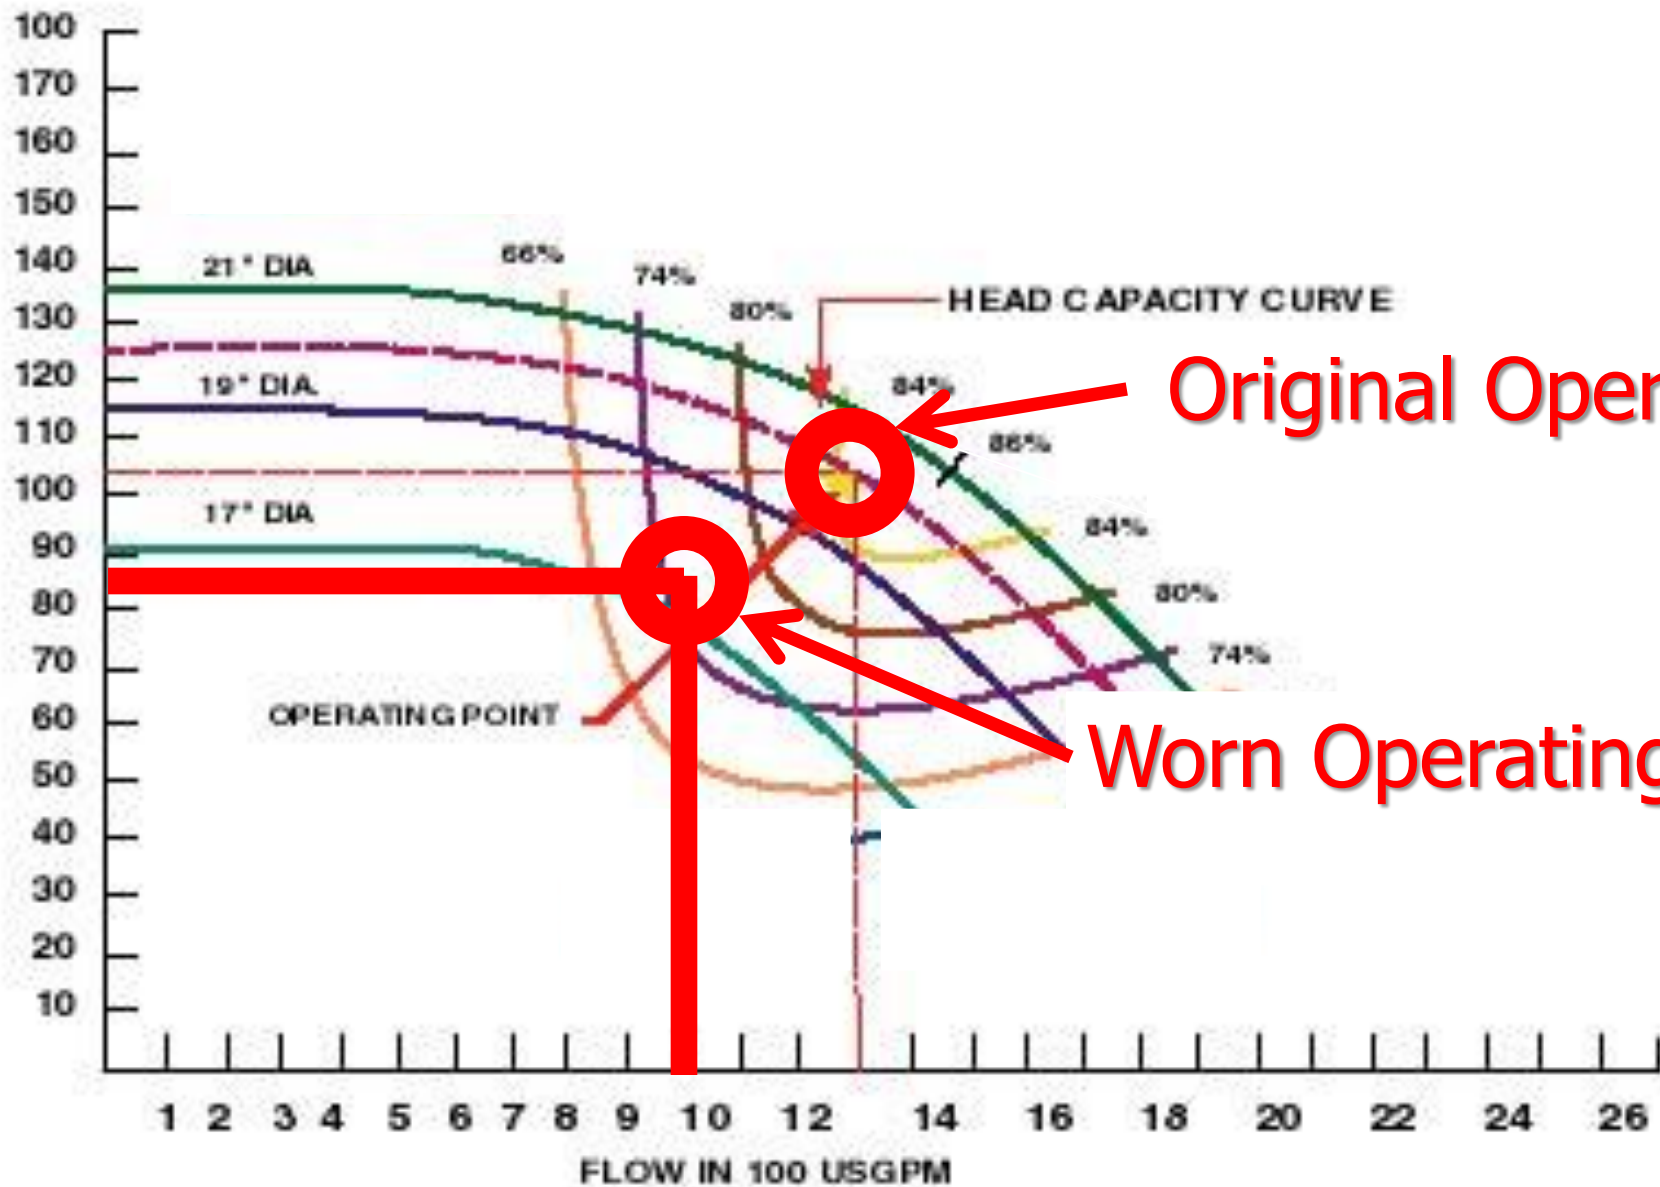
Check for Pump Wearout

HEAD IN  
FT

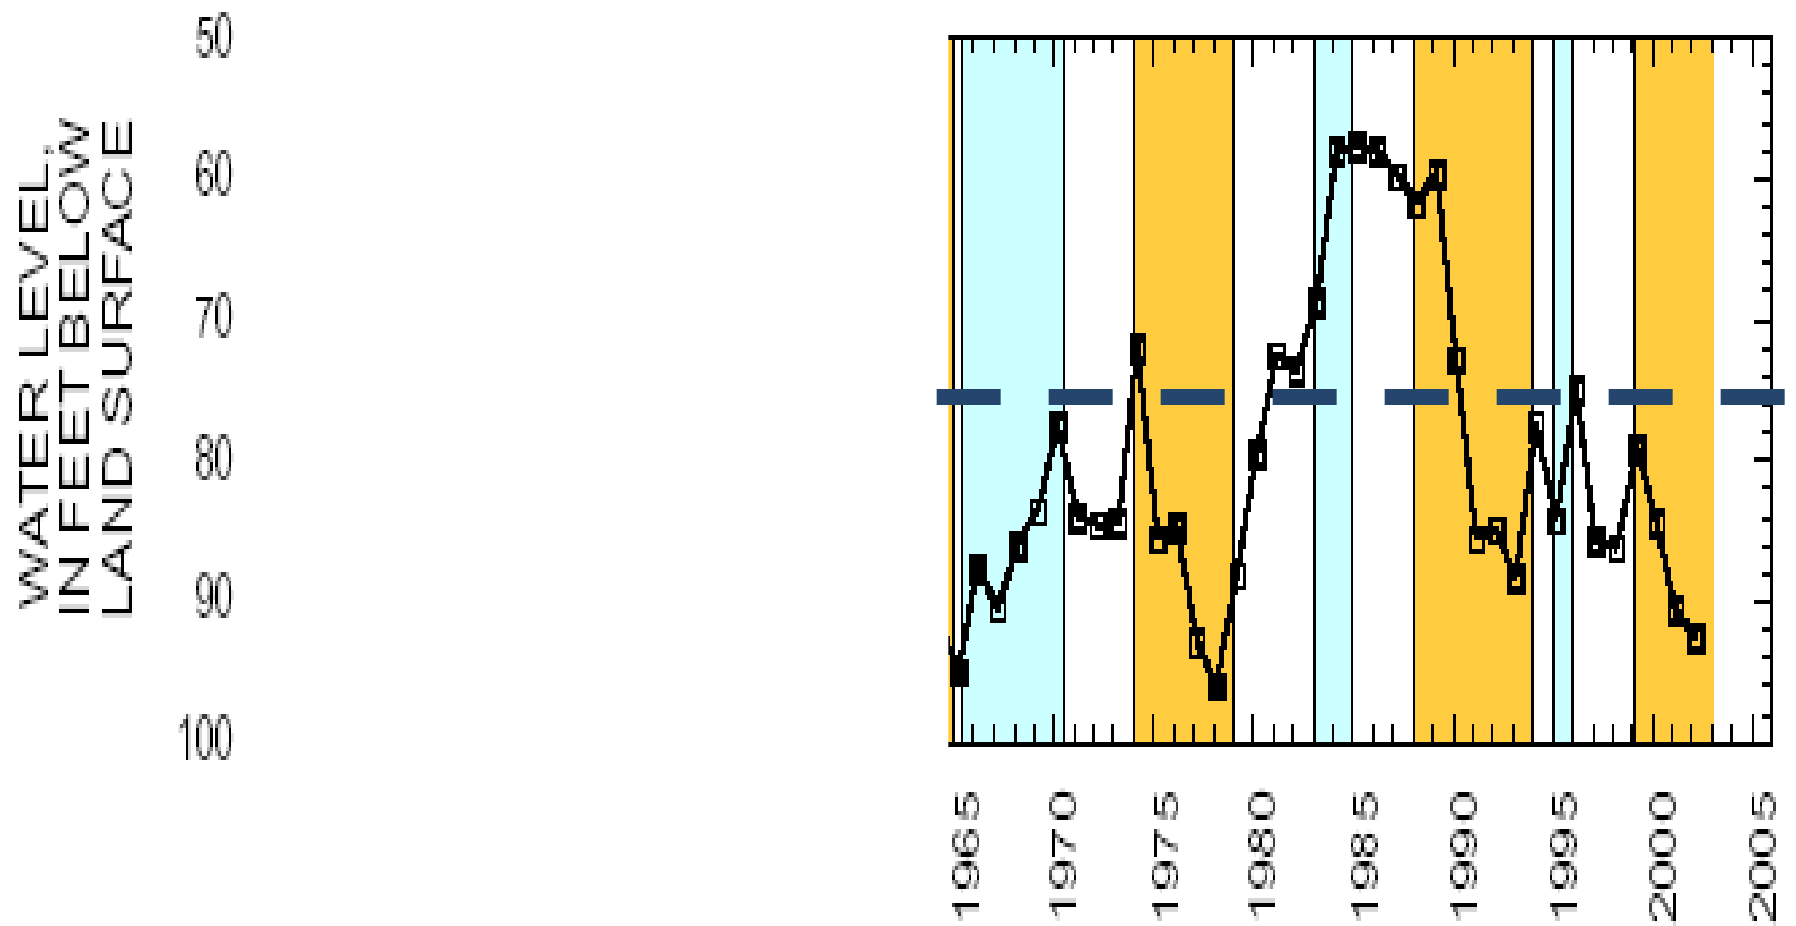
Figure 7. Water levels in a well near Cedar City, Utah.

Source: USGS

Check Aquifer Water Level Drop

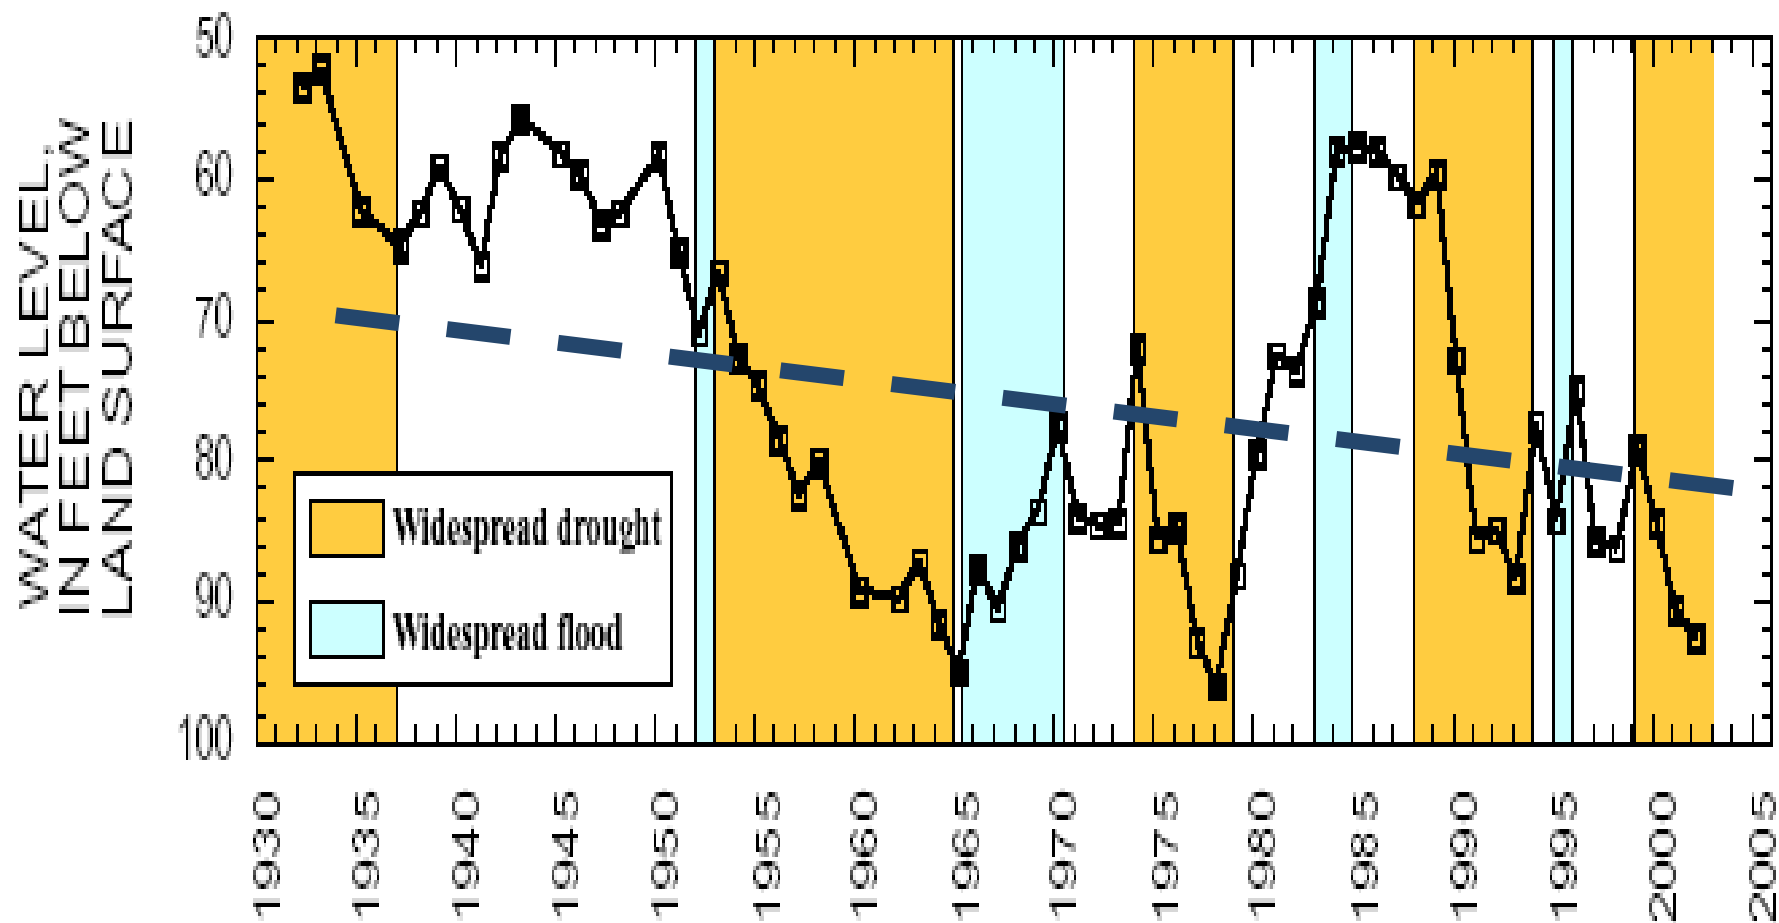
Figure 7. Water levels in a well near Cedar City, Utah.

Source: USGS
